WOOD DESTROYING PESTS AND ORGANISMS INSPECTION REPORT

| Building Address: 9999 W. Lefty Ln., Rightway City, CA 90009 | | Date of Inspection 11/22/2011 | Number of Pages 5 |
| General Description: Two story wood framed stucco single family residence with a composition roof and an attached garage | | Inspection Tag Posted: Garage | |

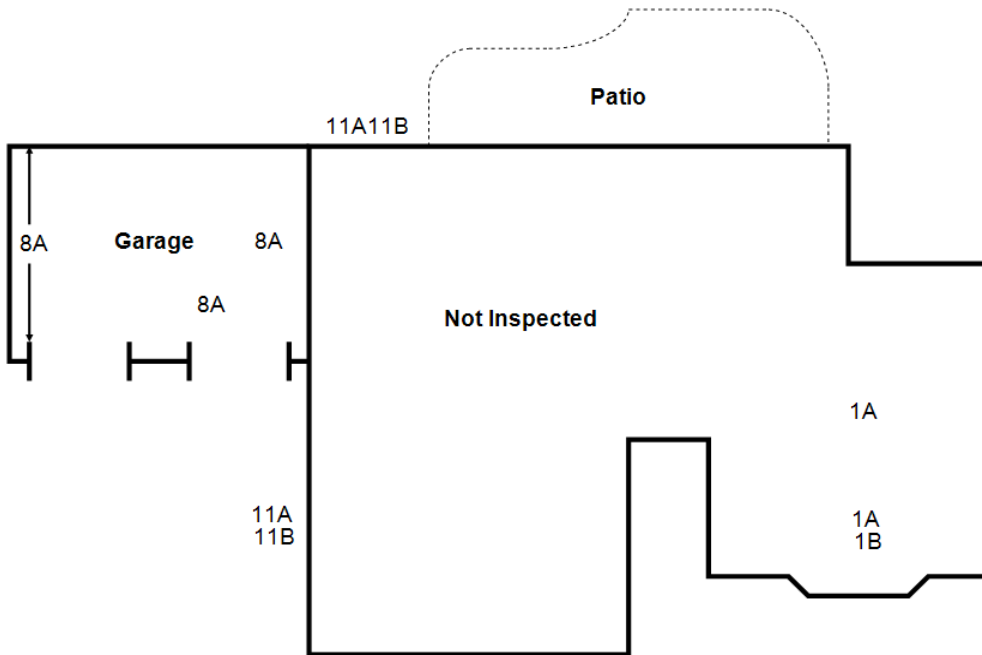
This Diagram is not to scale

1A (Section I)
FINDINGS: Evidence of subterranean termite infestation at subarea as indicated on the diagram.
RECOMMENDATION: Pressure "ROD" treat, trench application or low pressure spot spray as necessary. Break accessible sub tubes.

1B (Section I)
FINDINGS: Surface fungus condition visible at time of inspection at subarea as indicated on the diagram.
RECOMMENDATION: Scrape and chemically treat fungus condition. Patch any minor surface damage found during treatment.

8A (Section I)
FINDINGS: Evidence of dry-wood termite infestations at garage as indicated on the diagram.
RECOMMENDATION: Vacate the premises and seal the structure for fumigation with Vikane Gas. Remove or cover accessible evidence of infestation. Fumigation warranted for two years. Fumigation awareness notice must be signed prior to fumigation. See fumigation notice for terms and liabilities.

11A (Section I)
FINDINGS: Evidence of dry-wood termite infestations at exterior window trim as indicated on the diagram.
RECOMMENDATION: Vacate the premises and seal the structure for fumigation with Vikane Gas. Remove or cover accessible evidence of infestation. Fumigation warranted for two years. Fumigation awareness notice must be signed prior to fumigation. See fumigation notice for terms and liabilities.

11B (Section I)
FINDINGS: Evidence of termite damaged wood members noted at time of inspection at fascia as indicated on the diagram.
RECOMMENDATION: Replace termite damaged wood members as necessary. No painting is included in this estimate.
